DRAFT Midway Atoll NWR Seawall Repair Project – Coral Mitigation and Translocation Plan

The U.S. Fish and Wildlife Service (Service) and the Federal Aviation Administration (FAA) propose to replace sections of Sand Island's approximate 5,720-foot south seawall, as needed, to protect Henderson Field and to control erosion of wildlife habitat. The Service and the FAA have proposed a ten-year period for repairs, as funding is made available.

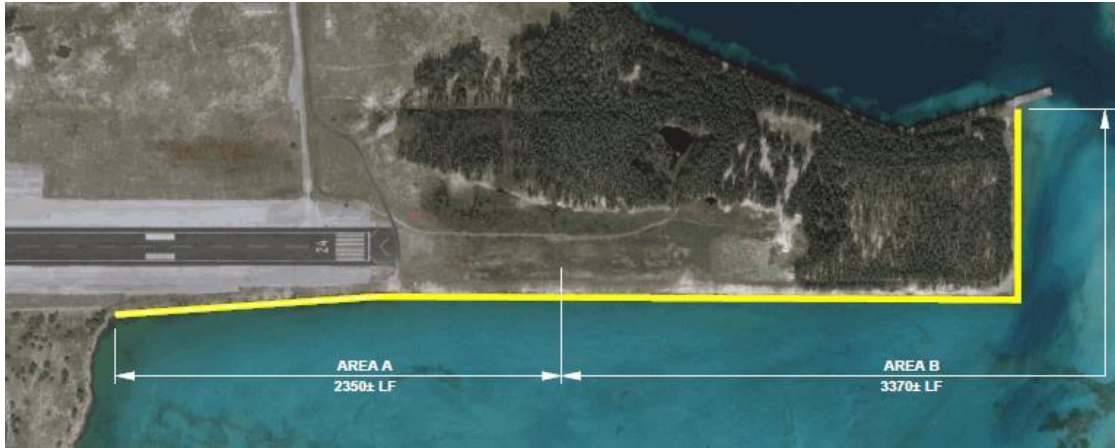
Figure 2. Estimated seawall repair area at Sand Island to be covered under programmatic U.S. Army Corps of Engineers Permit. Area A includes areas adjacent to Henderson Airfield and the Runway Safety Area. Area A maintenance responsibility belongs to the FAA. Area B is the remaining portion of the existing seawall, of which the responsibility belongs to Midway NWR. A total of 5,720 linear ft.

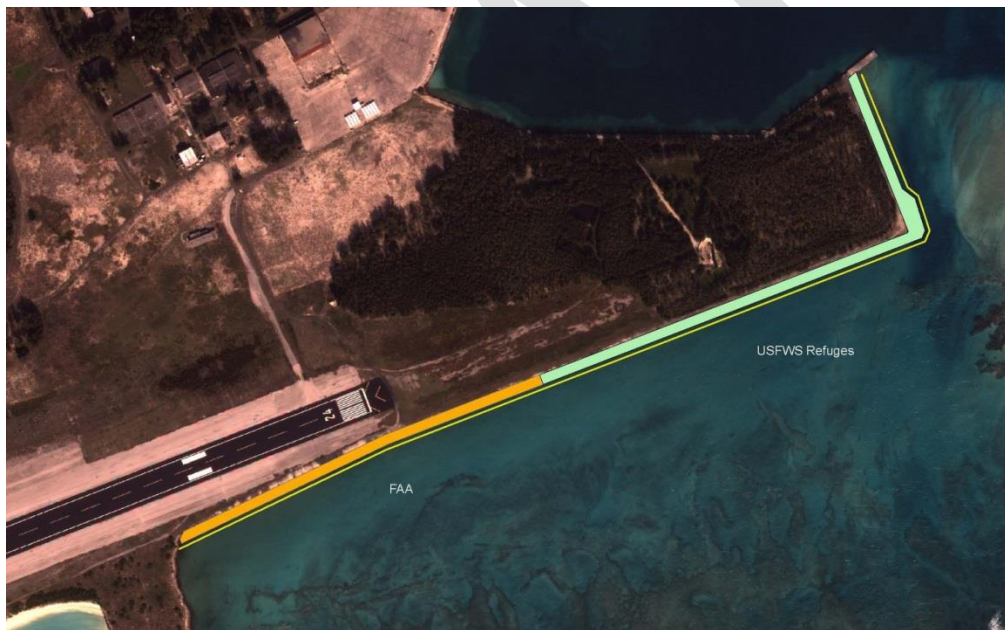
Figure 3. Potential footprint of project impacts, including silt curtain boundary (yellow line). Sand Island, Midway Atoll NWR.

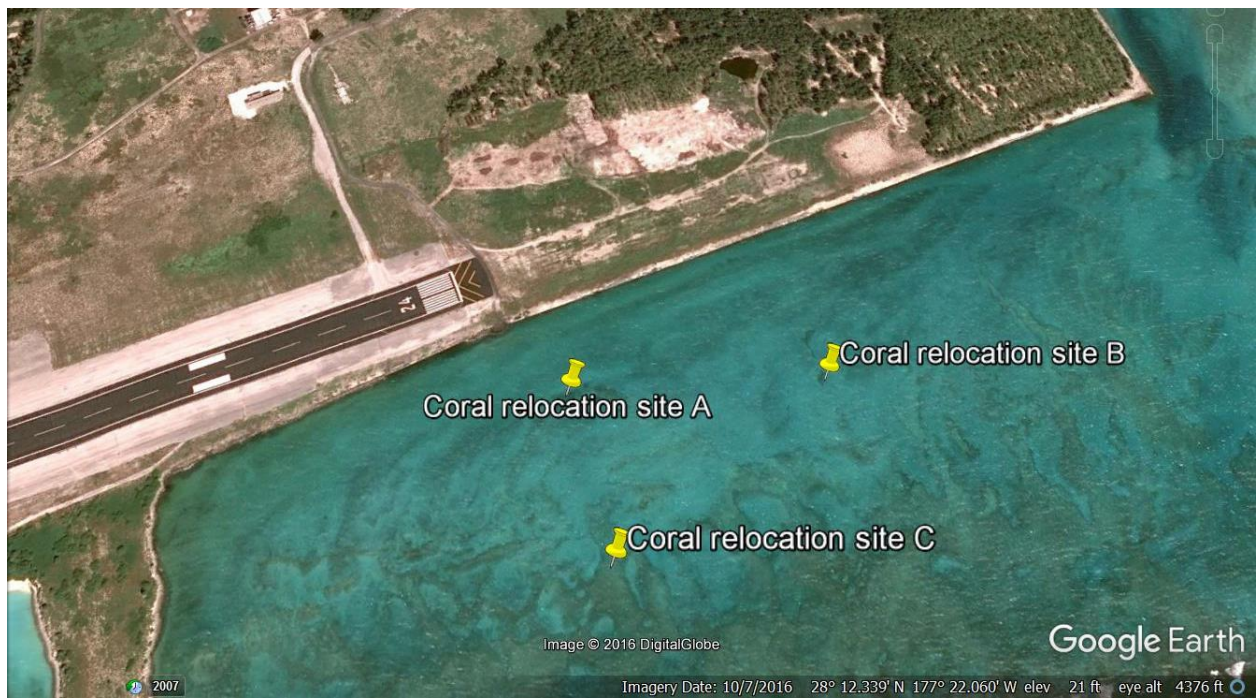
Figure 4. Potential coral transplantation locations for future seawall repairs.

The shallow area of the project will be accessed via the shore, while the deeper area (<2 m) will be accessed via a small boat. The project foot print will be surveyed to get an estimate of the number of corals that need to be translocated. Three areas to the south of the sea wall has been identified as potential transplant sites (Figure 4). These areas have been categorized by the NOAA Atlas of Shallow-Water Benthic Habitats of the Northwestern Hawaiian Islands as both uncolonized hardbottom, and uncolonized linear reef (NOAA 2003). The sites are approximately 450 ft. to over 1000 ft. from the sea wall, and well outside of the project foot print (Figure 4). Since the sites are somewhat close to the seawall, while remaining a safe distance away from the project area, the hope is that these sites will share many of the same environmental conditions as the harvest site. Transplant areas will be scouted prior to removing corals from the seawall and the substrate prepared for coral transplantation. Suitable transplant sites will be selected and marked with temporary markers, and the substrate at these sites will be cleaned with a wire brush to remove all macro and turf algae.
